**Ravenna Woods  
Forest Management Plan**  
(Preliminary)

Paul West  
Arboriculture & Restoration  
PO Box 16047  
Seattle, WA 98116  
206-767-0562

Friends of Ravenna Woods, Inc.

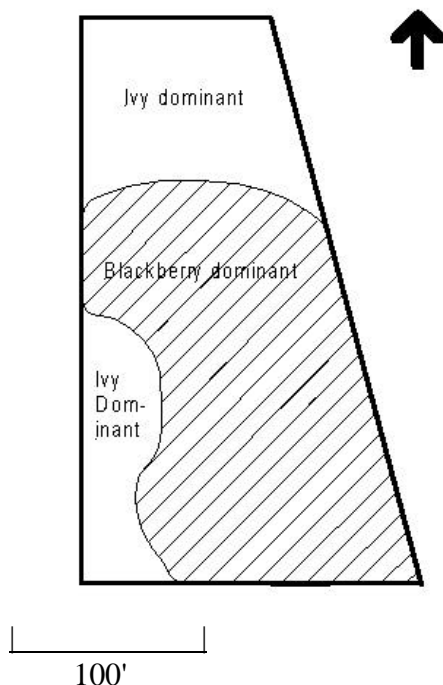
Figure 1. Ground layer vegetation dominants

The site contains two distinct vegetation areas. These correspond to the tree canopy and hydrology. The southeast portion of the site lacks tree canopy and contains saturated soils. It is dominated by Himalayan blackberry. Morning glory, reed canarygrass and nightshade are also found in these areas. The north and west portions of the site are dominated by bigleaf maple, while the ground layer is invaded by ivy. Holly, clematis and laurel are also present on this part of the site. See Figure 1 below. A notable native on the site is mock-orange. It occurs abundantly in the southwest corner of the site. This is an attractive medium height shrub that could be considered for restoration of the site.
